Assessing risk in abandoned and suspended wells in close proximity to urban development.

Abandoned well case studies

Wells in Calgary and Airdrie, Medicine Hat and Lethbridge

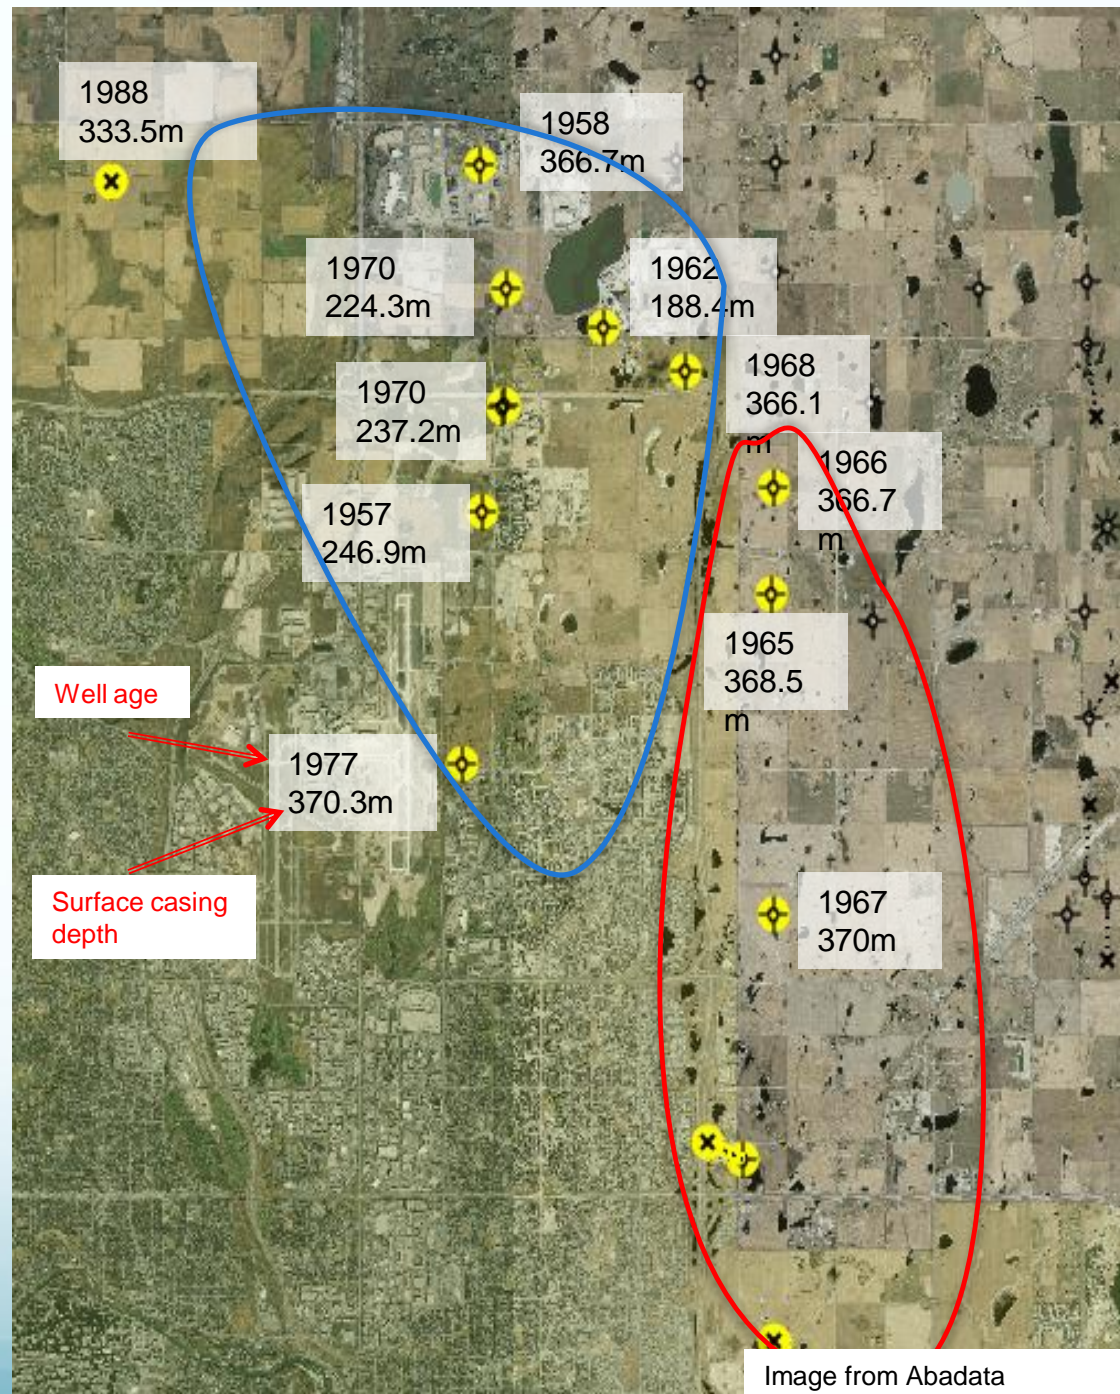
The majority of old wells do **NOT** have surface casing that extends below the base of the ground water protection (BGWP).

Therefore **OLD surface casing does not protect groundwater.**

Wells circled in blue have less than 50,000 ppm H₂S; wells circled in red have **greater than 200,000 ppm H₂S**.

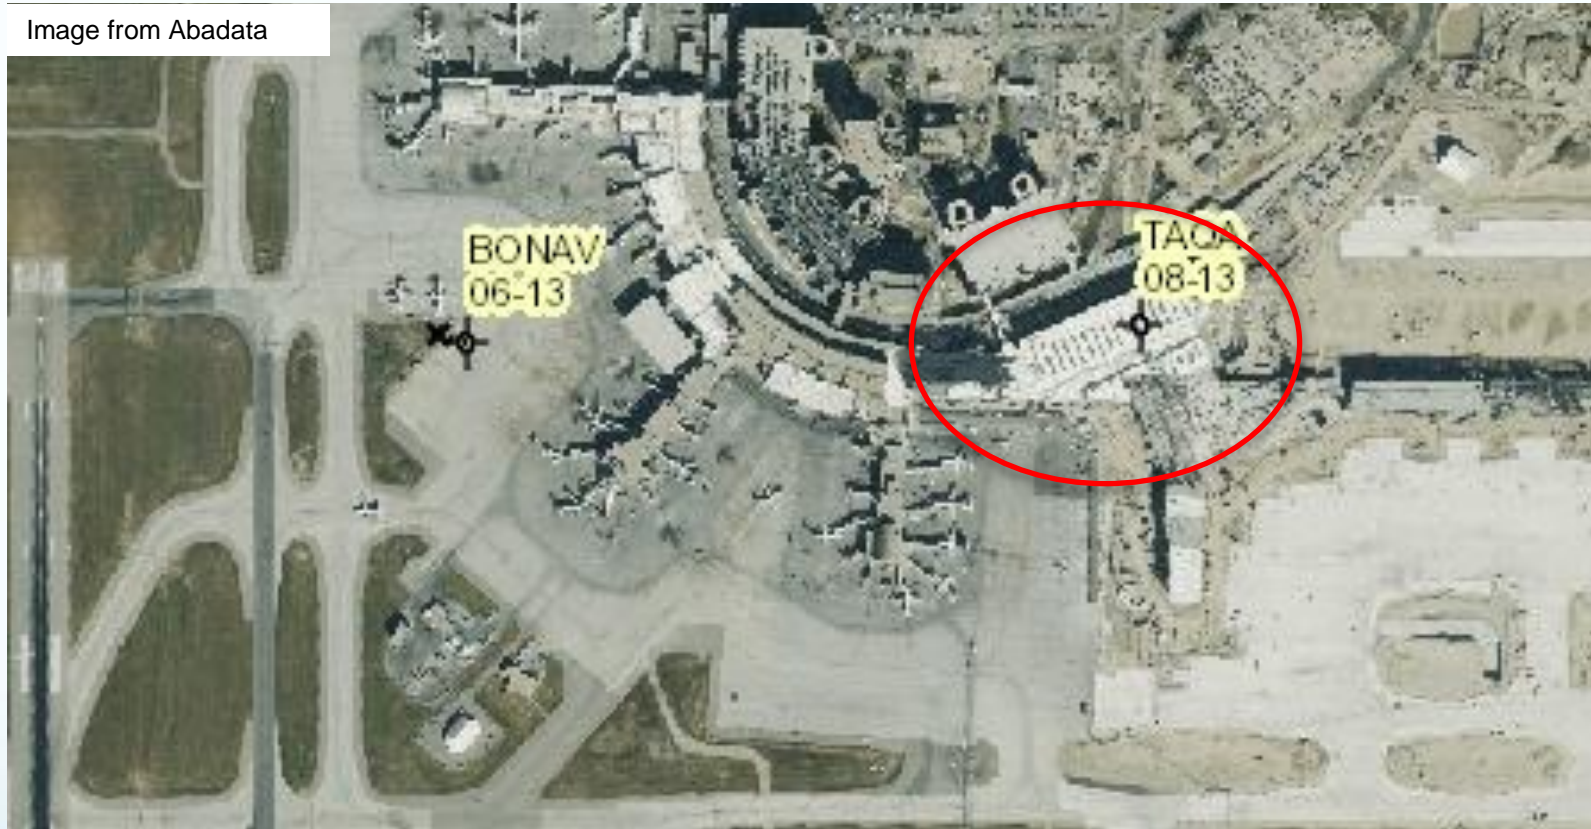
In Calgary: risk level of well 8-13-25-1W5

Abandoned in 1961

Surface casing depth 191.7: there is NO OTHER casing in this well

There is no cementing, plug back OR abandonment data for this well

Lies UNDERNEATH airport building

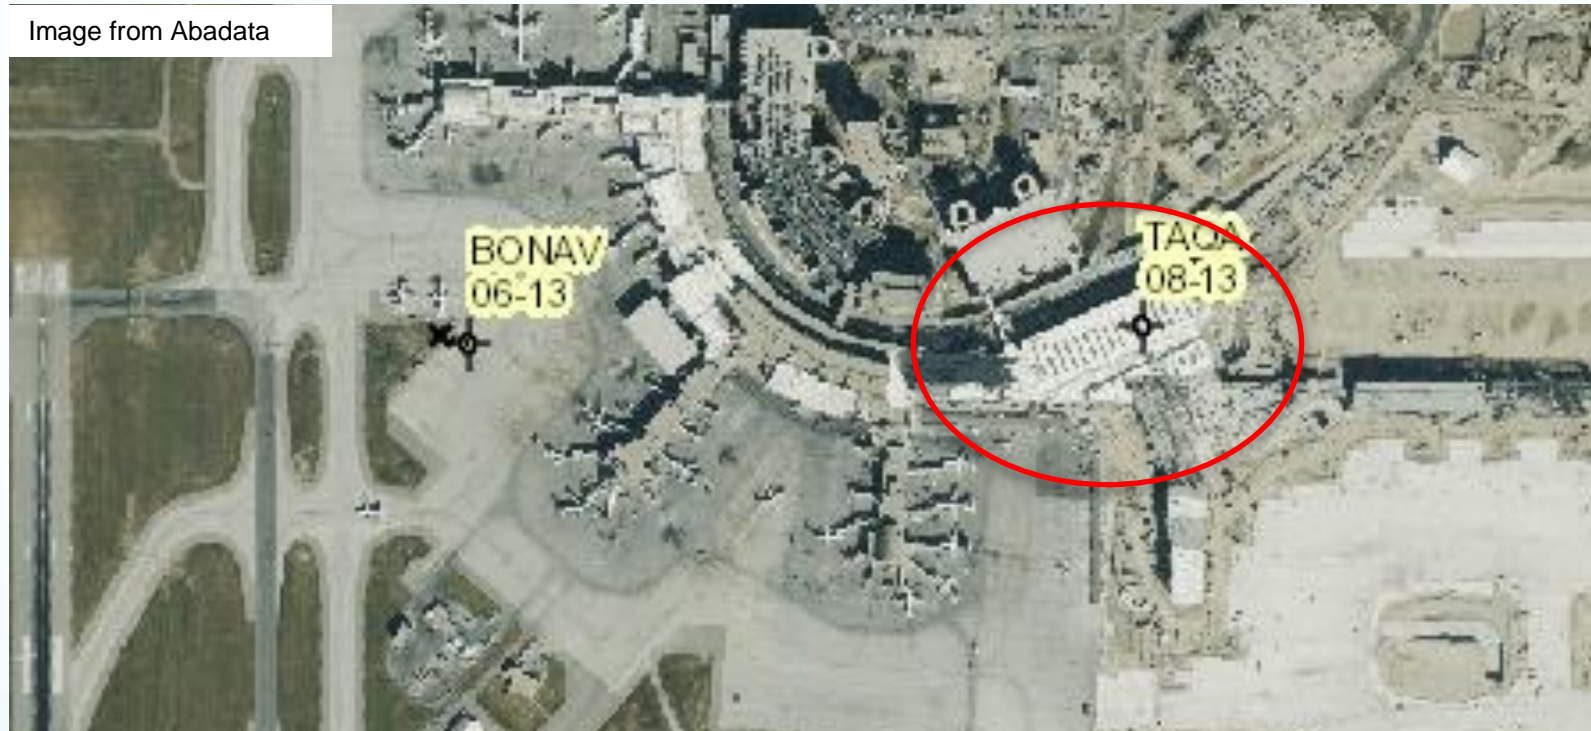
In Calgary: risk level of well 8-13-25-1W5M

Risk Category												
SCVF or GM History	Well Deviation	Cement Top	TVD (mKB)	Casing Failure History	Well Age	Inactive Well Status	Well Operation	H ₂ S Content (%)	Land Use	Protection of Useable Water Aquifers	Proximity to nearest water wells	Well Accessibility
No Historical SCVF or GM	Vertical no well logs	Unknown	1000-1999 mKB	Casing breakdown 50 % or greater	Spud pre 1975	N/A	all other wells types	No H ₂ S	Priority 1: Seniors/School /Hospital	Useable Water, Aquifers not Protected	500m < WSW ≤ 1 km Non-Drinking Water	Under Surface Structure

**Risk matrix total is 1640 out of 3080.
This is a low to medium risk well.**

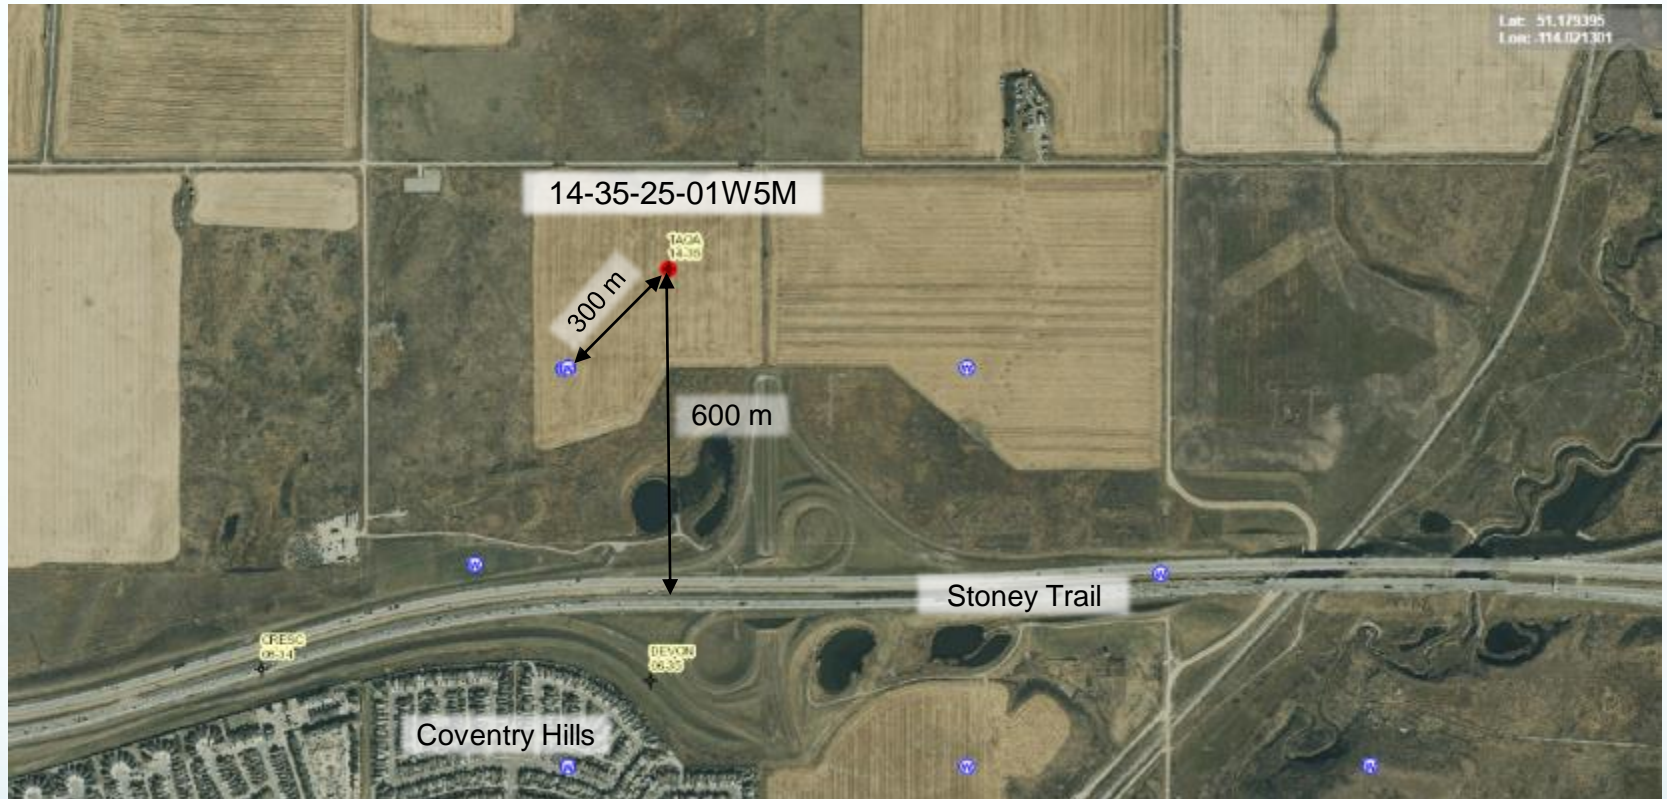
Well 14-35-025-01W5M AbaData View

Location: Calgary, Alberta
Abandoned Date: April 24, 1962

Risk Category													
SCVF or GM History	Well Deviation	Cement Top	TVD (mKB)	Casing Failure History	Well Age	Inactive Well Status	Well Operation	H ₂ S Content (%)	Land Use	Protection of Useable Water Aquifers	Proximity to nearest water wells	Well Accessibility	SCORE
No Historical SCVF or GM	Vertical with well logs	Unknown	1000-1999 mKB	Casing breakdown 50 % or greater	Spud pre 1975	Compliant	all other wells types	No H ₂ S	Priority 4: Agriculture	Useable Water, Aquifers not Protected	100 m < WSW ≤ 500 m Non-Drinking Water	Not Under Surface Structure	1560

- Well Name: Canpet Sarcee Calgary 14-35-25-1.
- Current Licensee & Operator: TAQA North Ltd.
- Cement Top: Unknown. Also, it can be assumed that, as the well was drilled & completed before 1975, so the probability of presence of cement around the surface casing from below the BGWP to surface will be low or even if its present it will be degraded condition, therefore, it can be concluded that groundwater is not protected from gas migration.
- Surface Casing Shoe Depth: 187.1 m & BGWP: 472.2 m
- Perforations: 1794.7 m to 1798.6 m.
- Bridge Plug Capped with Cement: At 1769.4 m.
- Risk Assessment Score: 1560 out of 3080.
- Therefore, it is a medium risk well.

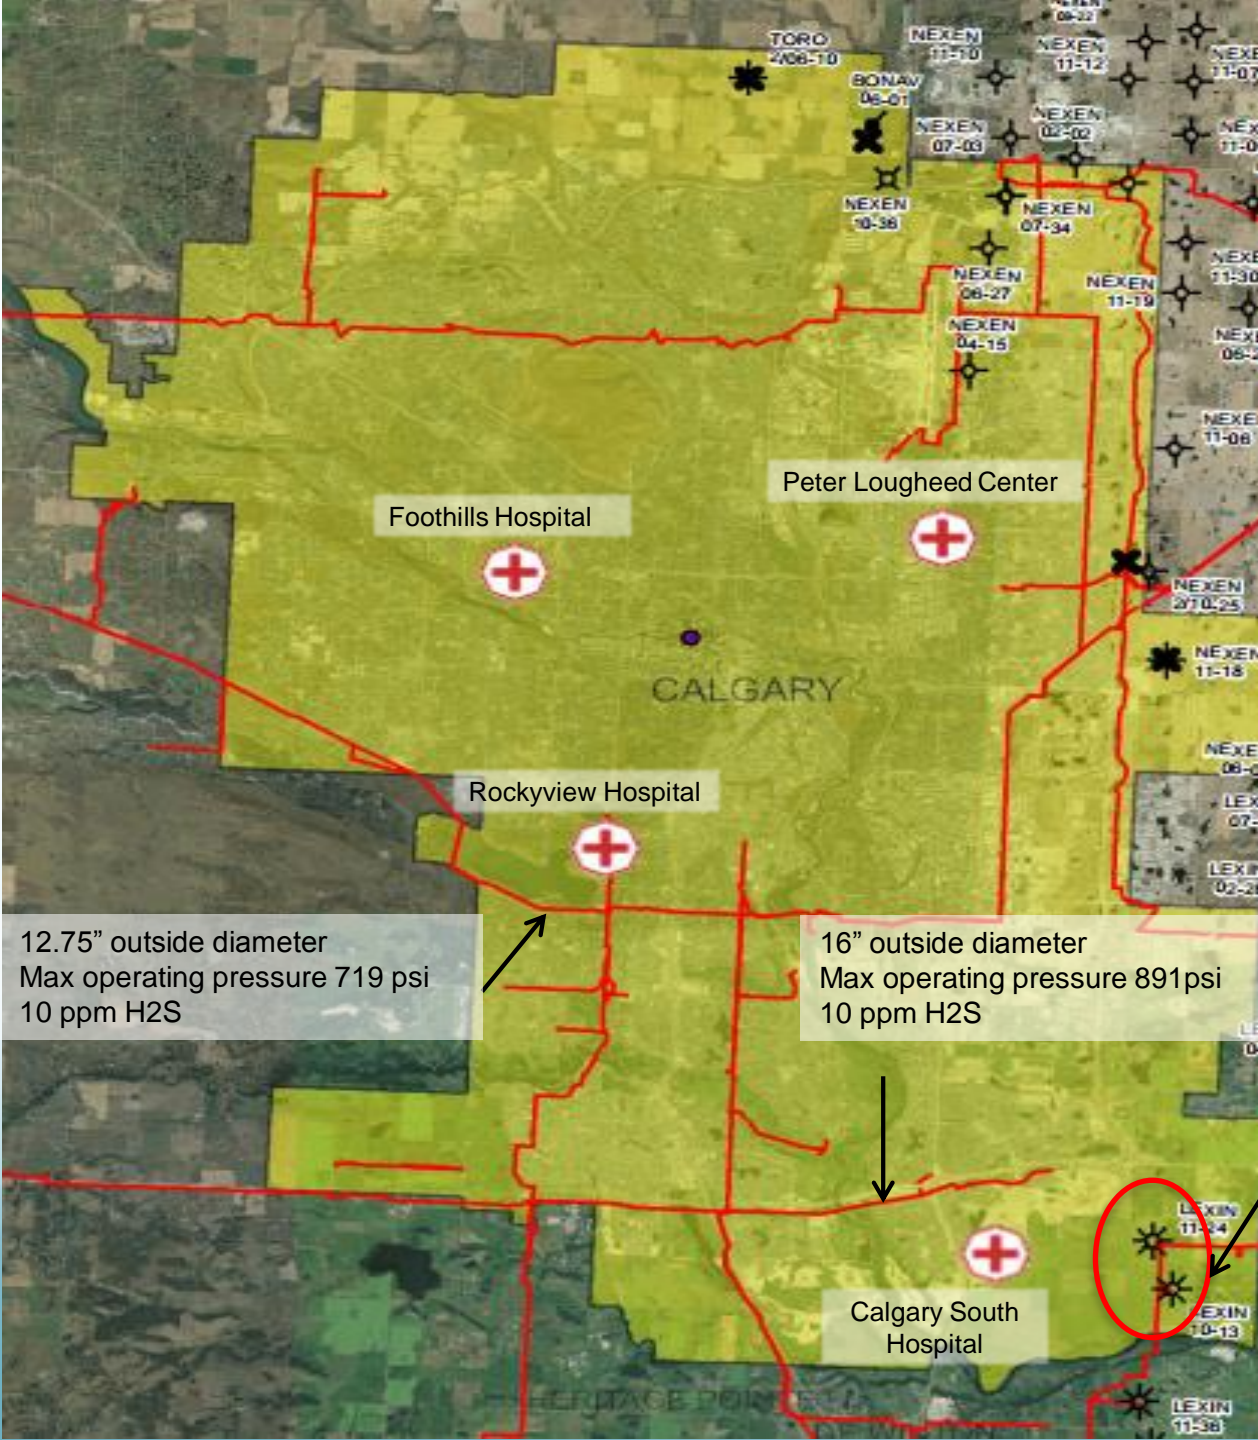
Sour Gas Pipelines in Calgary

ALL pipelines are currently **operating** and have 10 ppm H₂S.

The two Lexin wells are operating at **41,990 & 37,490** ppm

The southern pipeline is operating at **400,000** ppm whereas the eastern one is operating at **20,000** ppm & the pipeline is 4.2 km away from Calgary South Hospital.

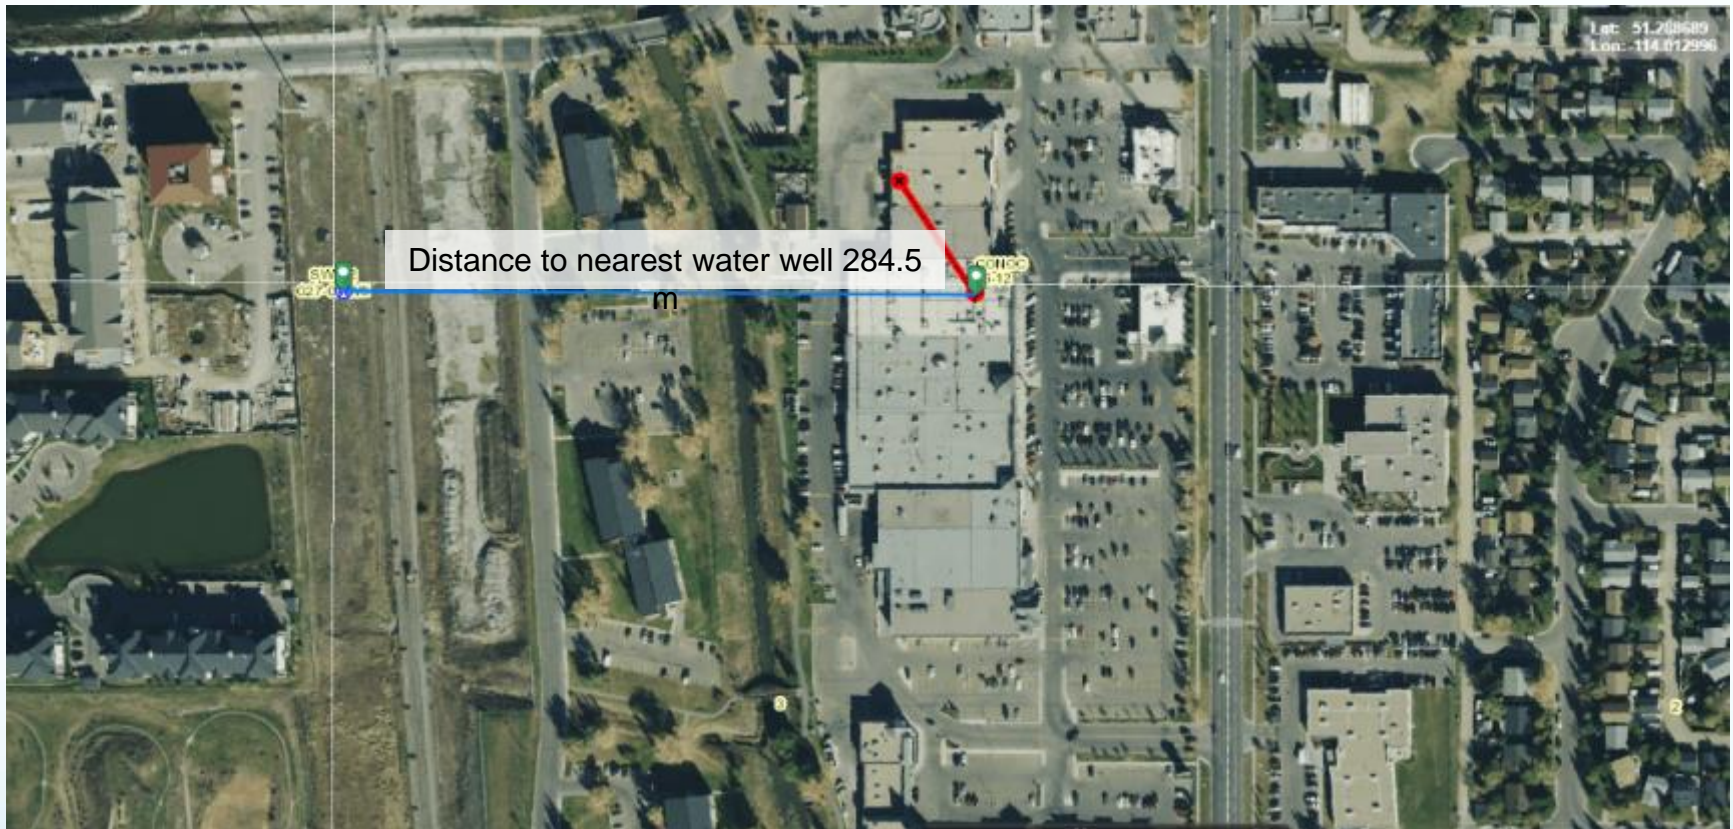
Well 06-12-027-01W5M AbaData View

Location: Airdrie, Alberta
Abandoned Date: August 25, 1977

Risk Category													
SCVF or GM History	Well Deviation	Cement Top	TVD (mKB)	Casing Failure History	Well Age	Inactive Well Status	Well Operation	H ₂ S Content (%)	Land Use	Protection of Useable Water Aquifers	Proximity to nearest water wells	Well Accessibility	SCORE
No Historical SCVF or GM	Deviated below 600 m KB	Unknown	2000-2999 mKB	Casing breakdown 50 % or greater	Spud pre 1975	Compliant	all other wells types	H ₂ S > 25%	Priority 3: Retail/Motel/Hotel	Useable Water, Aquifers not Protected	100 m < WSW ≤ 500 m Non-Drinking Water	Under Surface Structure	1950

- Well Name: Tipperary Et Al Crossfield 6-12-27-1.
- Current Licensee & Operator: ConocoPhillips Canada Resources Corporation.
- Cement Top: Unknown. Also, it can be assumed that the well was drilled & completed before 1975, so the probability of presence of cement around the surface casing from below the BGWP to surface will be low, therefore, it can be concluded that groundwater is not protected from gas migration.
- Surface Casing Shoe Depth: 371.2 m & BGWP: 542.4 m
- Perforations: 2705.1 m to 2714.9 m.
- Bridge Plug Capped with Cement: 2651.8 m to 2667.0 m.
- Risk Assessment Score: 1950 out of 3080.
- Therefore, it is a medium to high risk well.

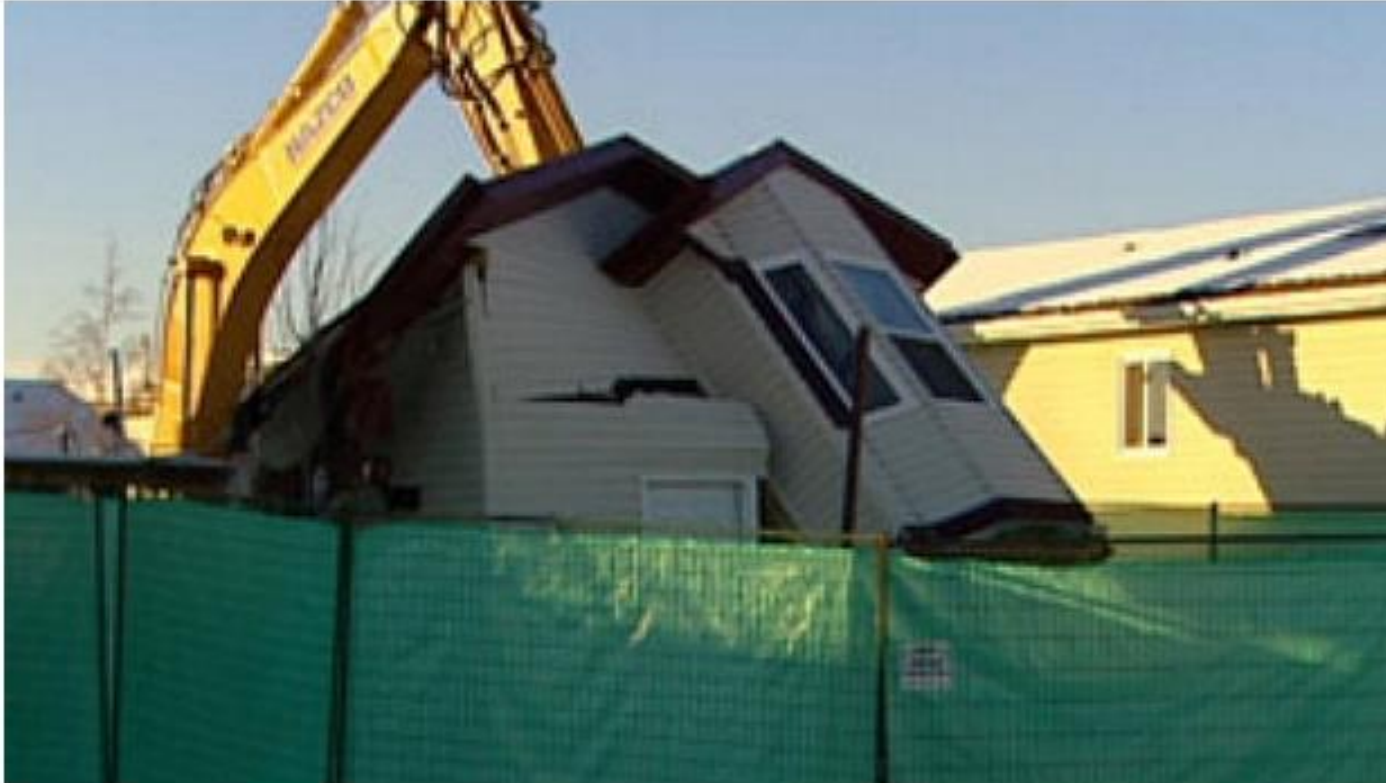
100/01-36-49-27W4

A home is demolished in Calmar, Alta. in December 2010 after a gas well was discovered leaking in the neighbourhood in 2008. (CBC)

- Five homes were demolished in Calmar in 2010 for re-abandonment due to sweet gas leaking from an old abandoned well.
- Residents were asked to leave in 2013 and 2015 while Imperial Oil tried to fix the leak.
- Shockingly, the well is still leaking today.

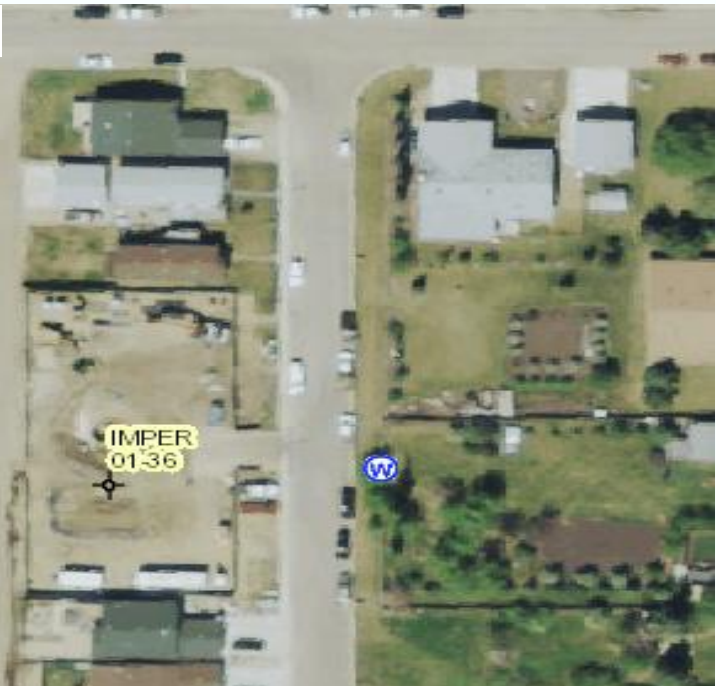
100/01-36-49-27W4

Risk Category												
SCVF or GM History	Well Deviation	Cement Top	TVD (mKB)	Casing Failure History	Well Age	Inactive Well Status	Well Operation	H ₂ S Content (%)	Land Use	Protection of Useable Water Aquifers	Proximity to nearest water wells	Well Accessibility
Serious SCVF or GM	Vertical no well logs	Unknown	1000-1999 mKB	Casing breakdown 50 % or greater	Spud pre 1975	Compliant	N/A	No H ₂ S	Priority 2: Residential Area playgrounds	Useable Water, Aquifers not Protected	WSW ≤ 100 m Non-Drinking Water	Under Residential Structure

**Risk matrix total is 2040 out of 3080
This is a **medium risk** well that **leaked**.**

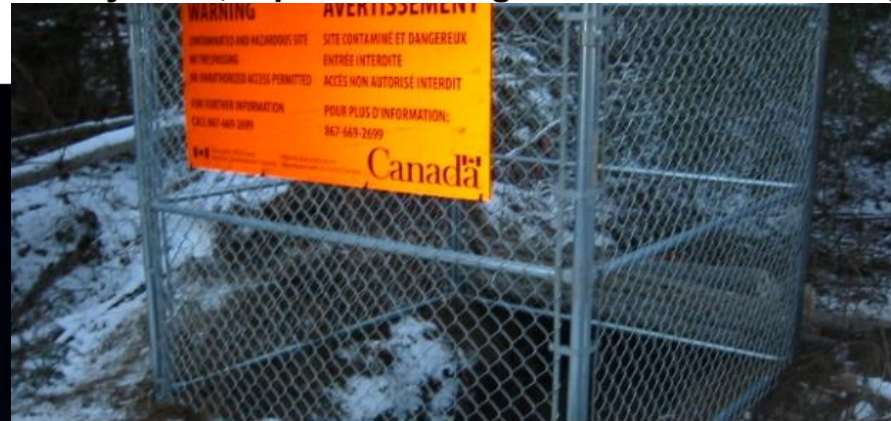
In Hay River, orphaned sour gas well at risk of leaking

Aboriginal Affairs says this well is not currently a threat to people or the environment, but is showing signs of corrosion. (AANDC)

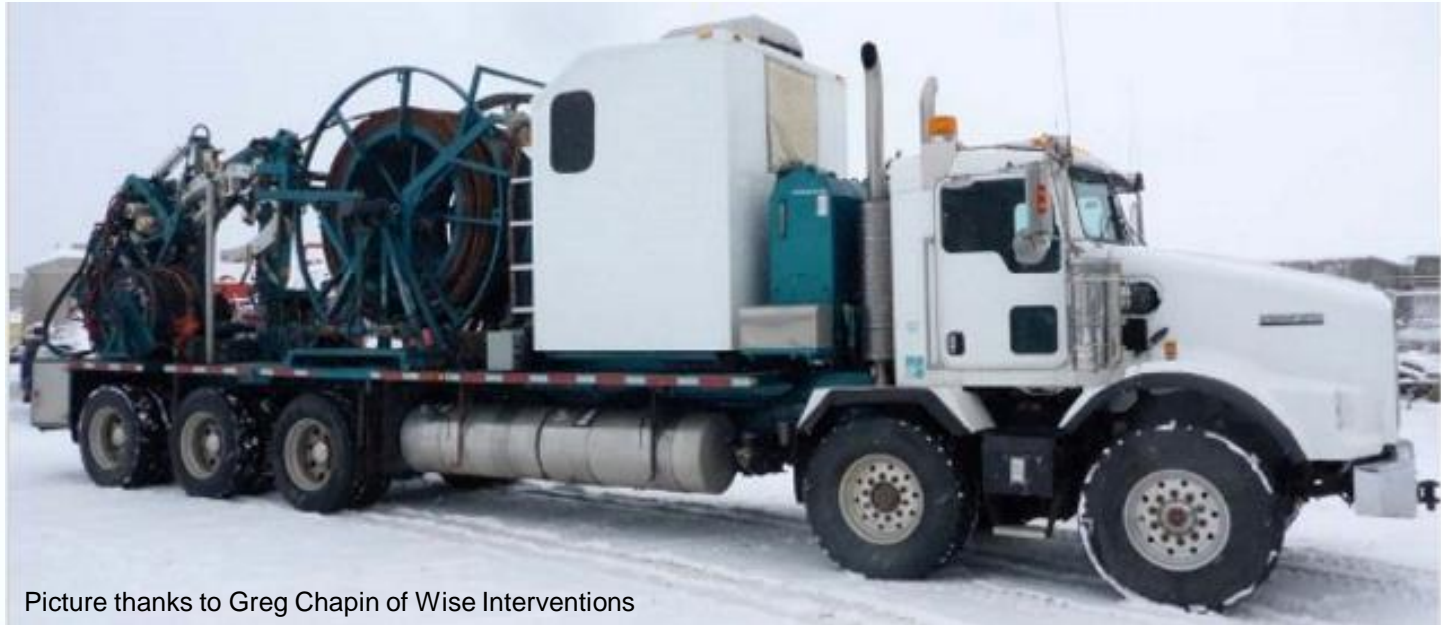
Smallest intervention rig

The SMALLEST coiled tubing unit that WISE Interventions has for well-site workovers is **3.3m wide by 12m long** (pictured above).

Additionally, ~2-3 meters is required between the wellhead and the back of the unit.

The AER only requires a **5m setback** from old abandoned wells: Obviously, as the Calmar example illustrates, 5m is simply not enough room to intervene and re-abandon a leaking gas well.

- Use of the Risk Matrix will help assess the risk level of each individual well
- Municipalities should consider increasing the set-back distance from 5 m to at least 15m to allow a small service rig to intervene and re-abandon a leaky well.
