COMMUNITY PLANNERS ASSOCIATION OF ALBERTA

HERITAGE CONSERVATION - COMMUNITY BENEFITS AND CHALLENGES

CONDITION ASSESSMENT, FEASIBILITY STUDY AND FUNCTIONAL PROGRAM

Case Study – Conservation of the St Albert Grain Elevators

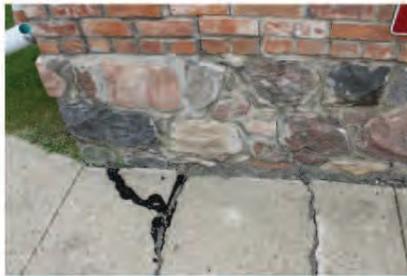
Fig. 50. Mortar deterioration in foundation wall at base of northeast corner of chapel.

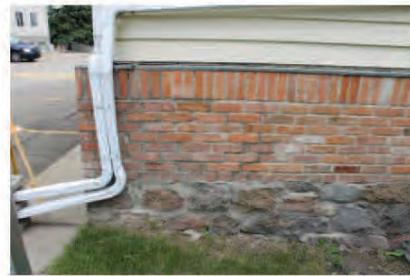
Fig. 51. Mortar deterioration at northwest corner of chapel.

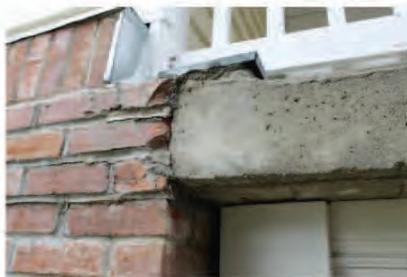
Fig. 52. Sample brick and mortar

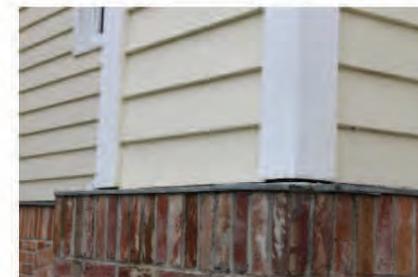
Fig. 54. Typ. paint conditions on exterior siding.

In general the exterior walls appear to be in Good condition, with some minor paint deterioration and cupping noted. At the intersection of the wood siding with the flashing above the first floor brick, there were a few areas of localized rot noted, especially at the base of the corner boards.

Where the stair structures abut each facade, some of the wood siding has been cut away to allow for structural connections and may be allowing moisture ingress into the assembly. This is not readily evidenced on the exterior of the wood siding but is worth investigating through exploratory openings in the next phase of the project.

Similarly, the wood siding was restored in the 1980s and does not appear to require any extensive remediation in the short term. Where localized areas of rot were noted at the flashing intersection, these areas should be repaired using dutchman technique following flashing repair/adjustments. The siding should be inspected regularly (every 5 years) as part of a routine maintenance program.

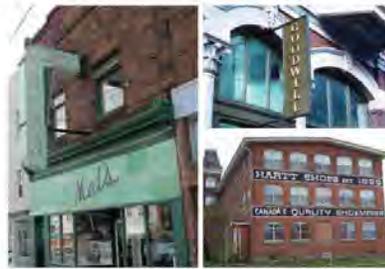
New signs (top right) should be respectful with the building in terms of size, scale, texture, style and colour. They should also not obscure, damage or detract character-defining elements. In some cases, as Mills Fab Room in Seattle, WA (left), signs added later become character-defining elements in their own right. Character defining signage should also be maintained despite a change in use, such as the painted sign for the farm store and the factory in Hudsons Bottom (right), which has been converted into apartments.
