Assessing risk in abandoned and suspended wells in close proximity to urban development.

Abandoned well case studies

Wells in Calgary and Airdrie, Medicine Hat and Lethbridge

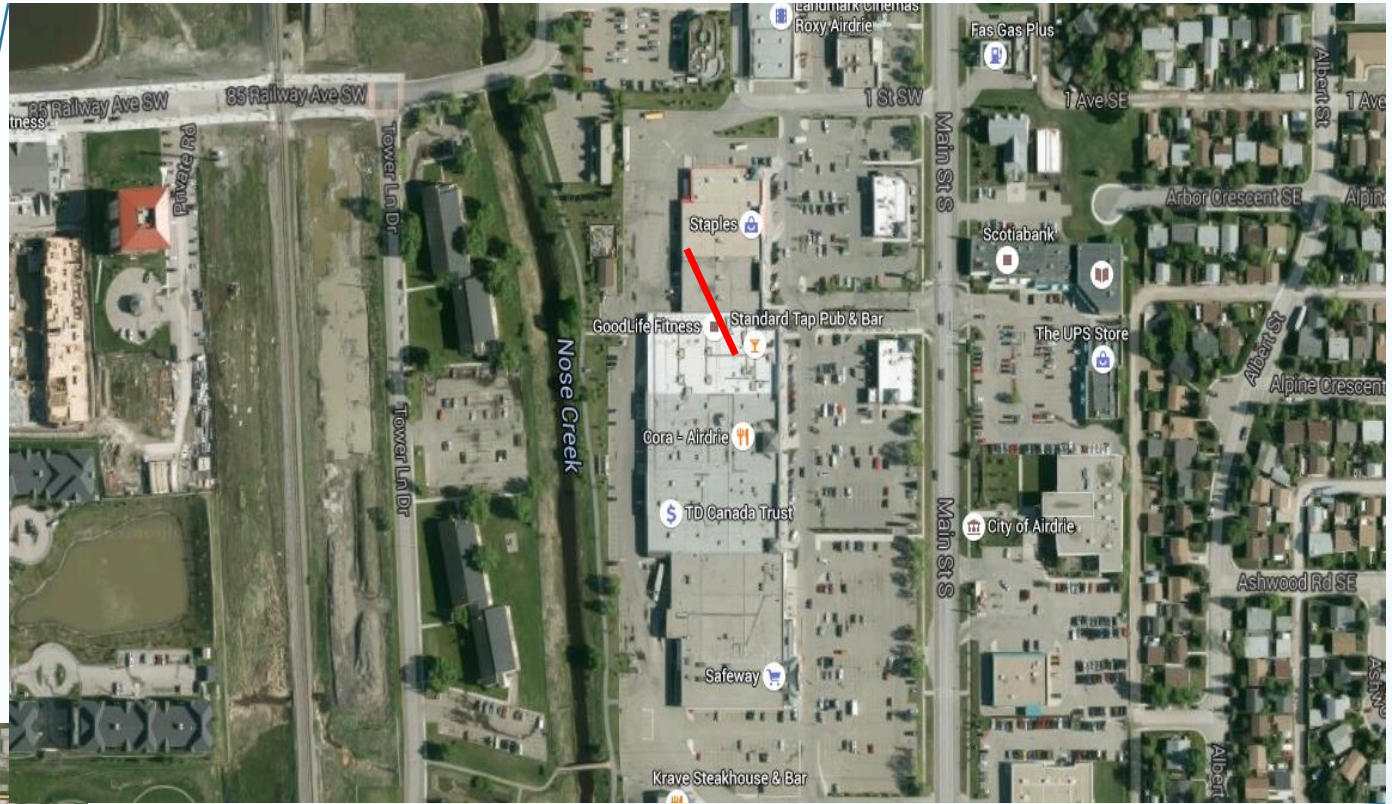
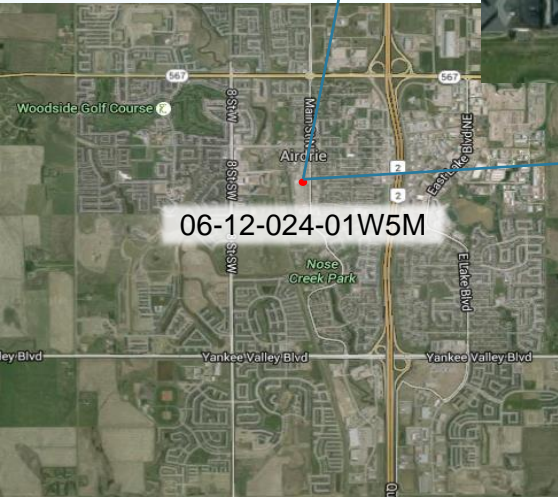
Well 06-12-027-01W5M Google Map View

Risk Category													
SCVF or GM History	Well Deviation	Cement Top	TVD (mKB)	Casing Failure History	Well Age	Inactive Well Status	Well Operation	H ₂ S Content (%)	Land Use	Protection of Useable Water Aquifers	Proximity to nearest water wells	Well Accessibility	SCORE
No Historical SCVF or GM	Deviated below 600 m KB	Unknown	2000-2999 mKB	Casing breakdown 50 % or greater	Spud pre 1975	Compliant	all other wells types	H ₂ S > 25%	Priority 3: Retail/Motel/Hotel	Useable Water, Aquifers not Protected	100 m < WSW ≤ 500 m Non-Drinking Water	Under Surface Structure	1950

- Well Name: Tipperary Et Al Crossfield 6-12-27-1.
- Current Licensee & Operator: ConocoPhillips Canada Resources Corporation.
- Cement Top: Unknown. Also, it can be assumed that the well was drilled & completed before 1975, so the probability of presence of cement around the surface casing from below the BGWP to surface will be low, therefore, it can be concluded that groundwater is not protected from gas migration.
- Surface Casing Shoe Depth: 371.2 m & BGWP: 542.4 m
- Perforations: 2705.1 m to 2714.9 m.
- Bridge Plug Capped with Cement: 2651.8 m to 2667.0 m.
- Risk Assessment Score: 1950 out of 3080.
- Therefore, it is a medium to high risk well.

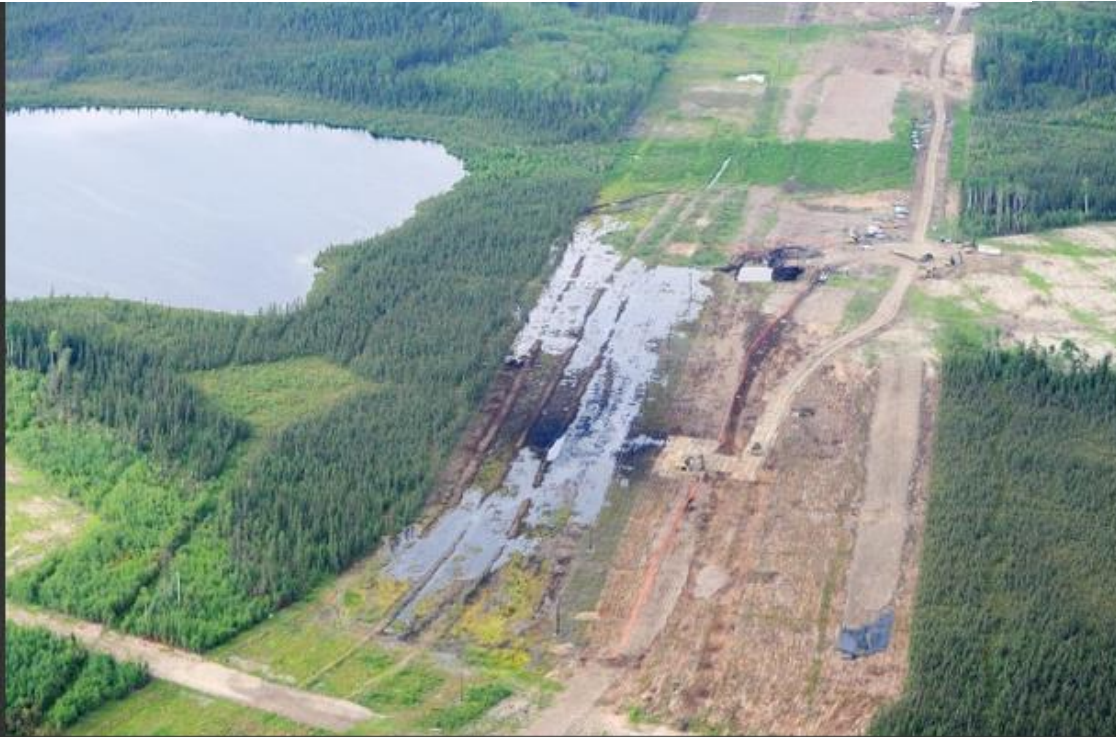
Spilled oil rests on the dirt and grass near Nexen's Long Lake facility near Fort McMurray on Friday, July 17, 2015. The spill, which is enough to fill two Olympic-sized swimming pools, was discovered Wednesday afternoon. *GARRETT BARRY / FORT MCMURRAY TODAY*

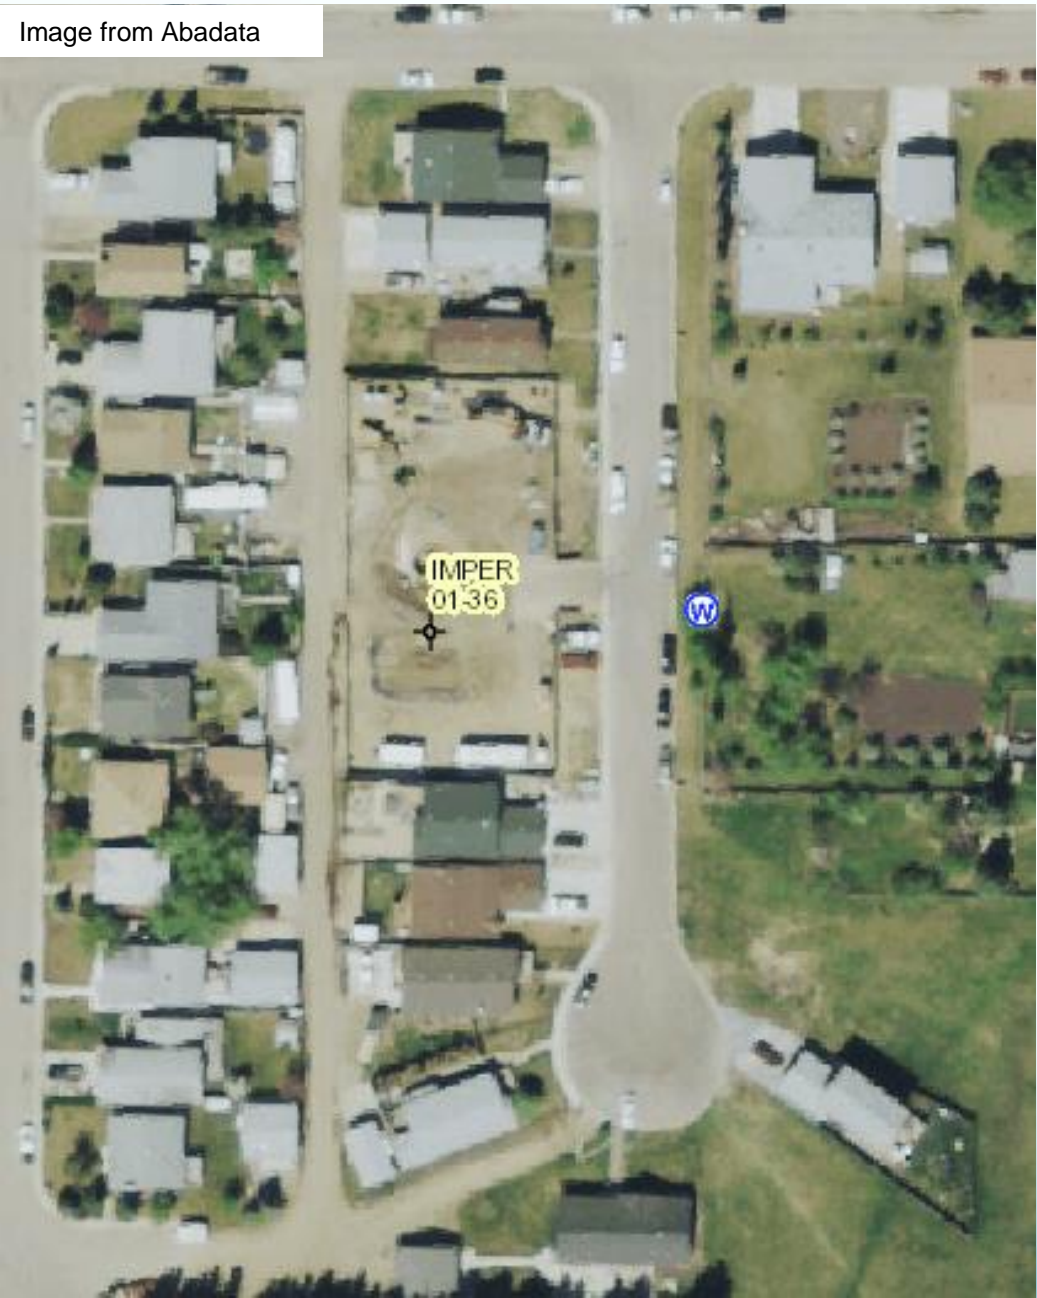
- Five homes were demolished in Calmar in 2010 for re-abandonment due to sweet gas leaking from an old abandoned well.
- Residents were asked to leave in 2013 and 2015 while Imperial Oil tried to fix the leak.
- Shockingly, the well is still leaking today.

**Risk matrix total is 2040 out of 3080
This is a **medium risk** well that **leaked**.**

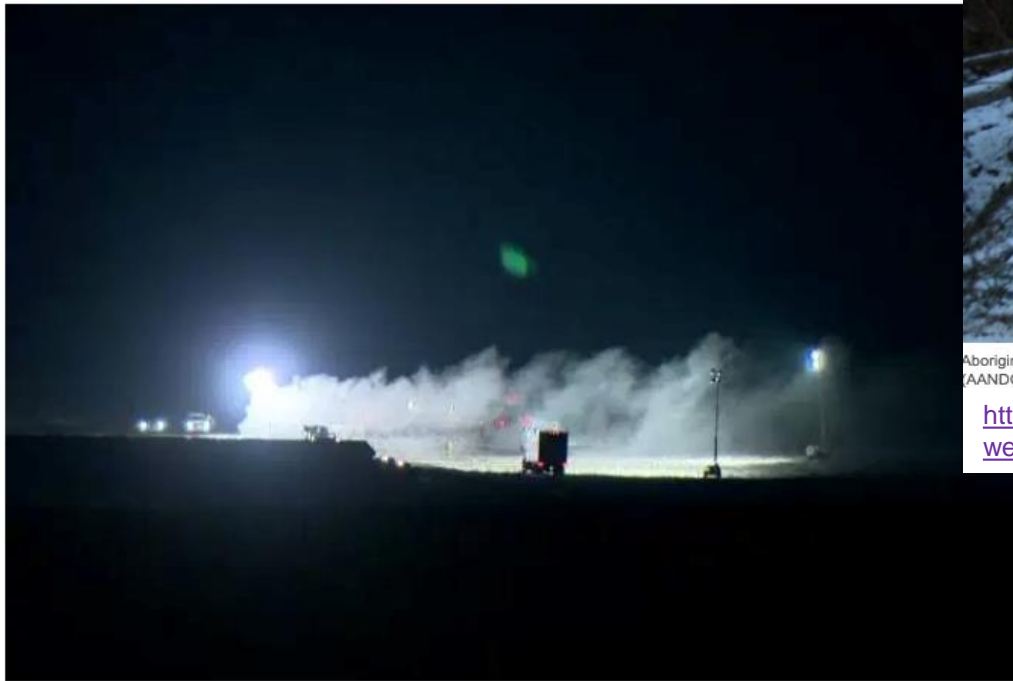
Crews work to cap sour gas well southwest of Airdrie.

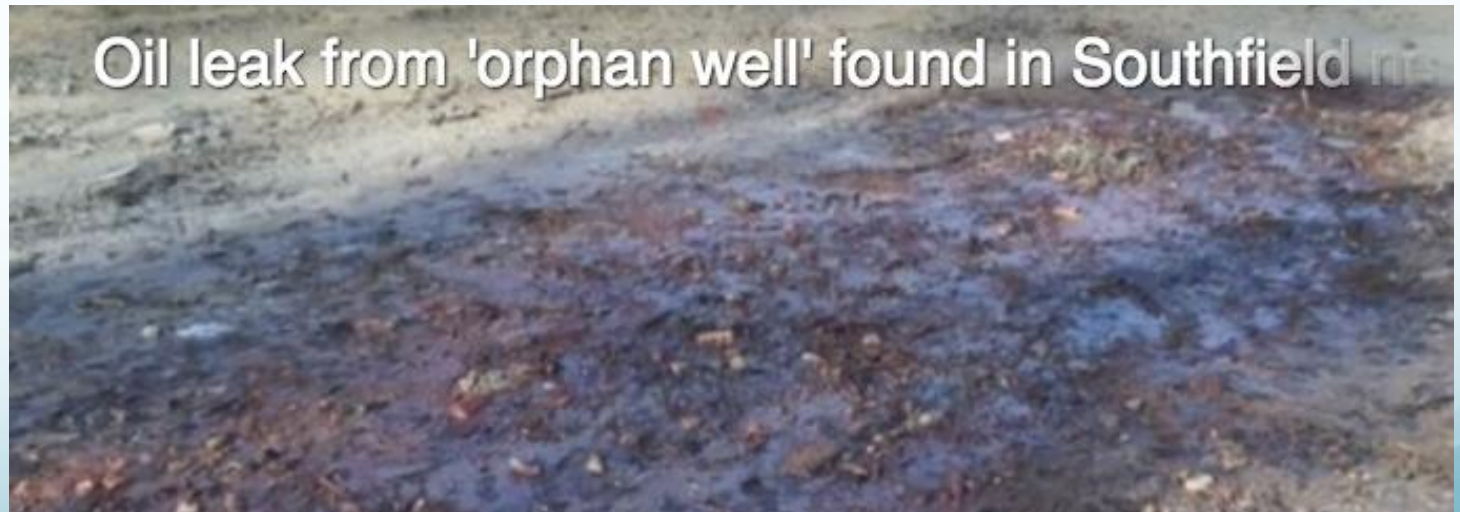
Oil leaking from an abandoned well in a Southfield neighborhood is running into a culvert that drains into a creek that goes to the Rouge River
